# **Intel® Mobile Celeron™ Processor Specification Update**

Release Date: August 1999

Order Number: 244444-007

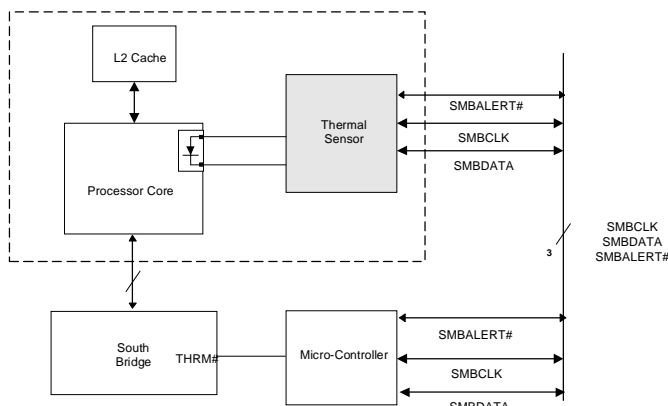
Figure 1. An Example of Microcontroller Driven Thermal Management

**PROBLEM:** The Intel Celeron Processor Mobile Module has a thermal sensor that monitors the processor core's temperature. Please note that desktop systems could have a similar thermal device. The thermal sensor asserts SMBALERT# if the processor temperature exceeds the temperature limits set in the Alarm Threshold Registers ( $T_{HIGH}$ ,  $T_{LOW}$ ). It also sets the corresponding Status Register bits to identify the cause of the interrupt. Figure 1 gives one example of the how the SMBALERT# signal could be used in a system.

Under the conditions described below, the thermal sensor incorrectly generates the SMBALERT# interrupt. *All* of the following conditions must be met to trigger a false interrupt:

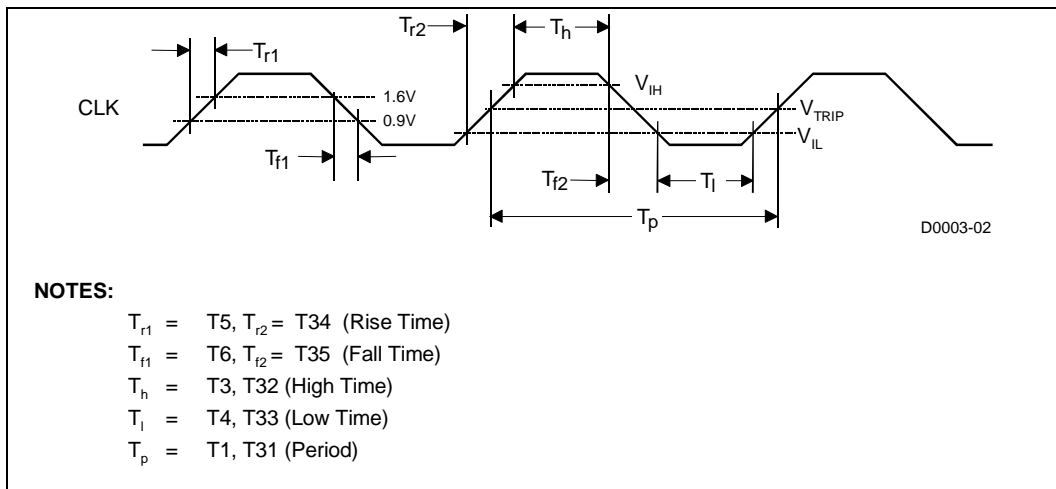
**Figure 3.3 Generic Clock Waveform**

Figure 3.3 in the *Intel® Mobile Celeron™ Processor in  $\mu$ PGA1 and BGA1 Packages at 366 MHz, 333 MHz, 300 MHz, and 266 MHz* datasheet (Order Number 245112-003) has been updated. The following figure is to replace the one in the above document.
